historic structure report  
architectural data section

FORT JEFFERSON

NATIONAL MONUMENT / FLORIDA

BY: LOUIS ANDERSON  
APRIL 1988

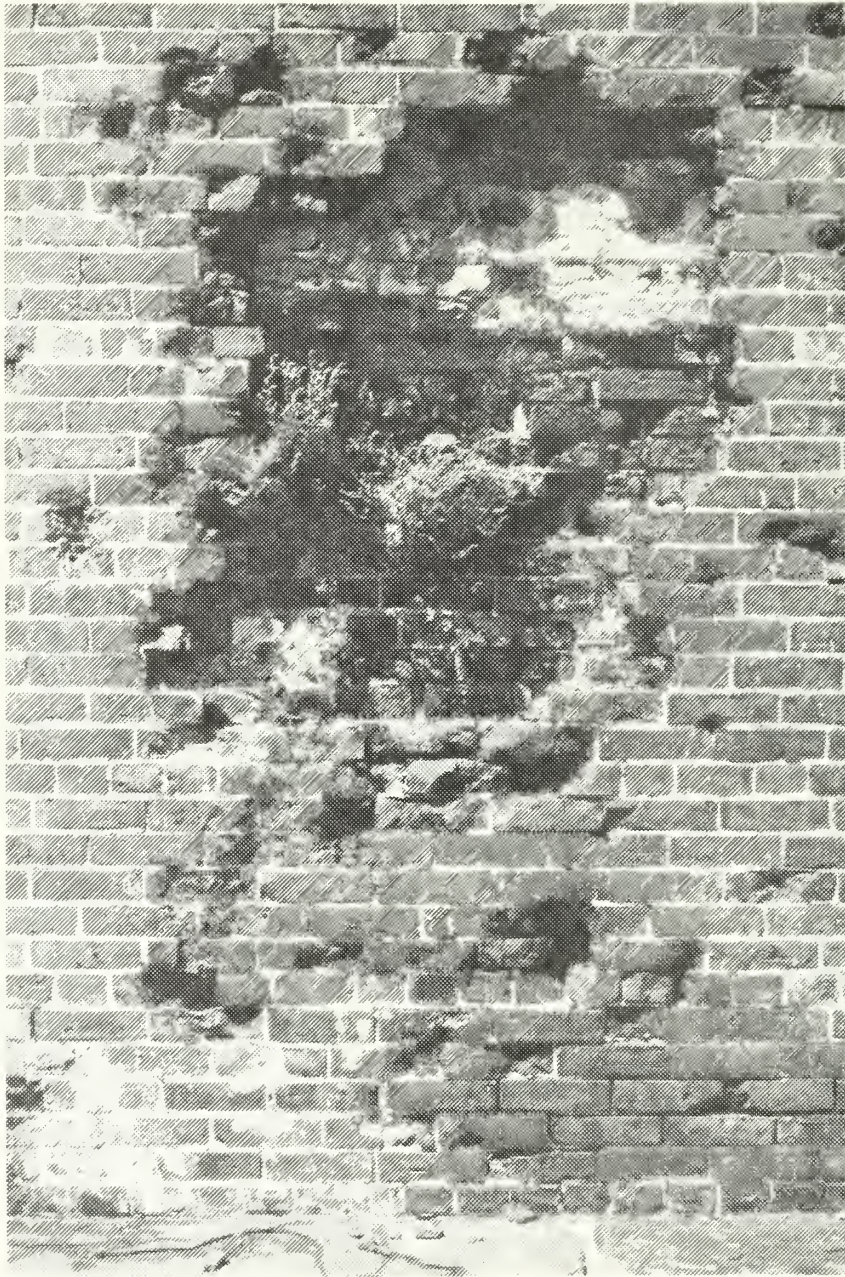
**Figure 6      PRESENT CONDITION**

DAMAGE TO LARGE MAGAZINE

Recommended treatment of the large magazine will be aimed at the stabilization of its present condition. Work involved would include primarily repointing but, where necessary, brick replacement and grouting of cracks as well.

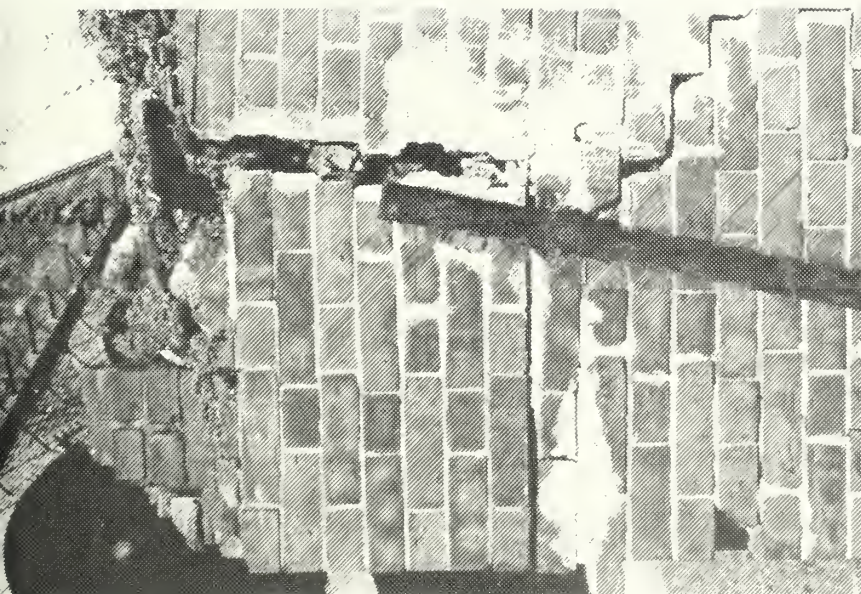
**Figure 9**

SHOT FURNACE  
CRACKING

Recommended stabilization treatment for the shot furnace will involve disassembly of brick coursing to structural cracks, preparation of measured drawings and photographs to document the disposition of the internal elements of the structure, removal of exfoliating iron tie rods and any other ironwork which may be determined to contribute to the structural failure of the furnace walls, and subsequent reassembly of the materials to historic appearance.

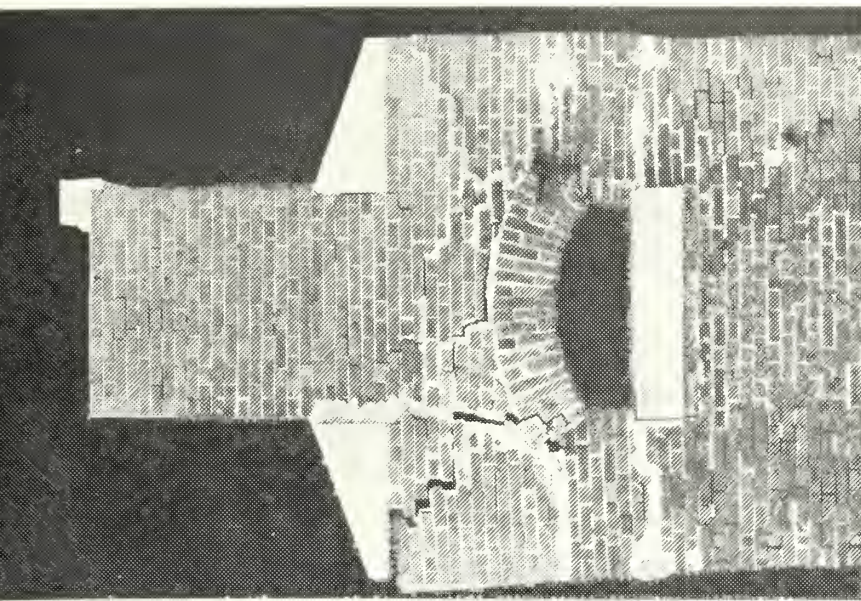
**Figure 10**

SHOT FURNACE  
BRICK DISPLACEMENT

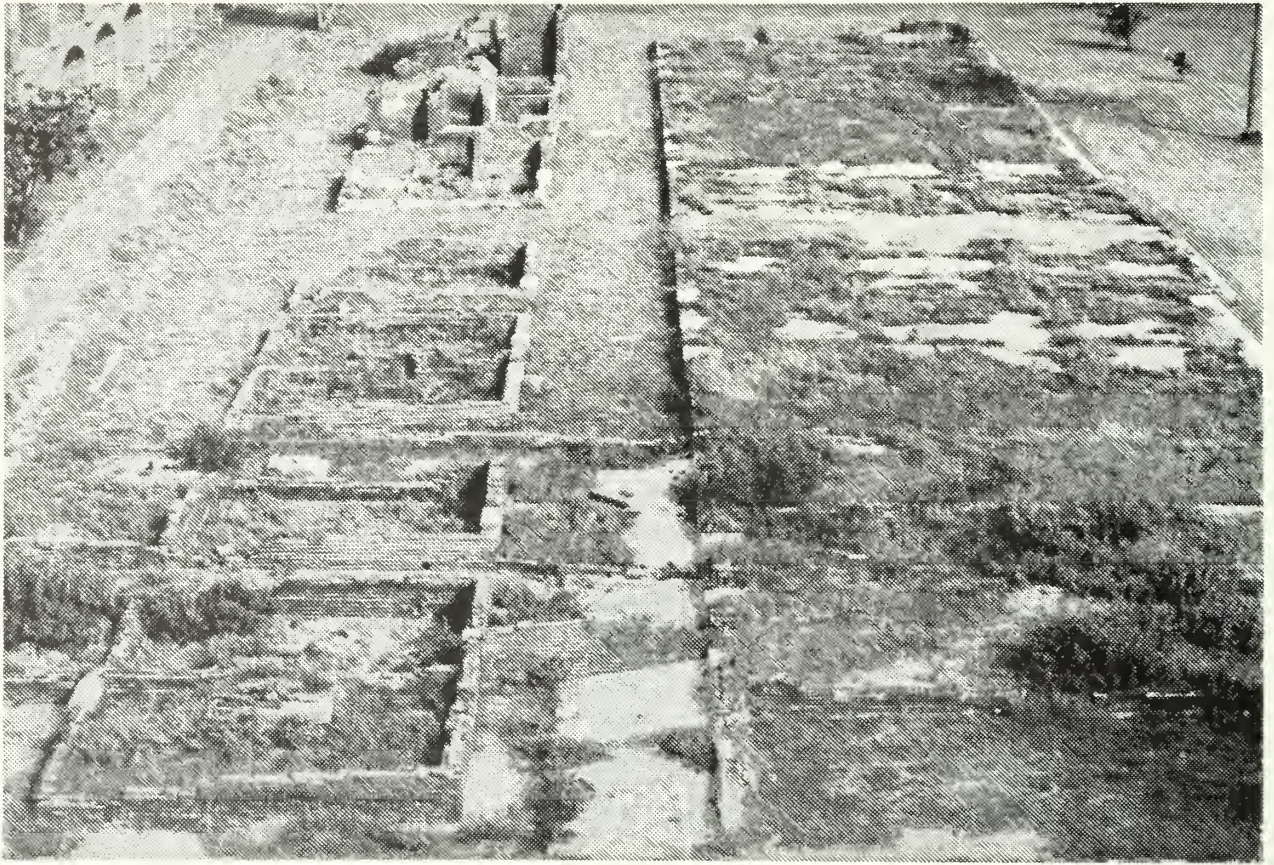
**Figure 12 PRESENT CONDITION**

OFFICERS' QUARTERS RUINS

The recommended treatment of the officers' quarters foundation is to preserve its present condition for use as an interpretive feature. Work involved may include spot repointing, brick replacement and selective patching of cracked or spalling concrete, as well as routine removal of encroaching vegetation.

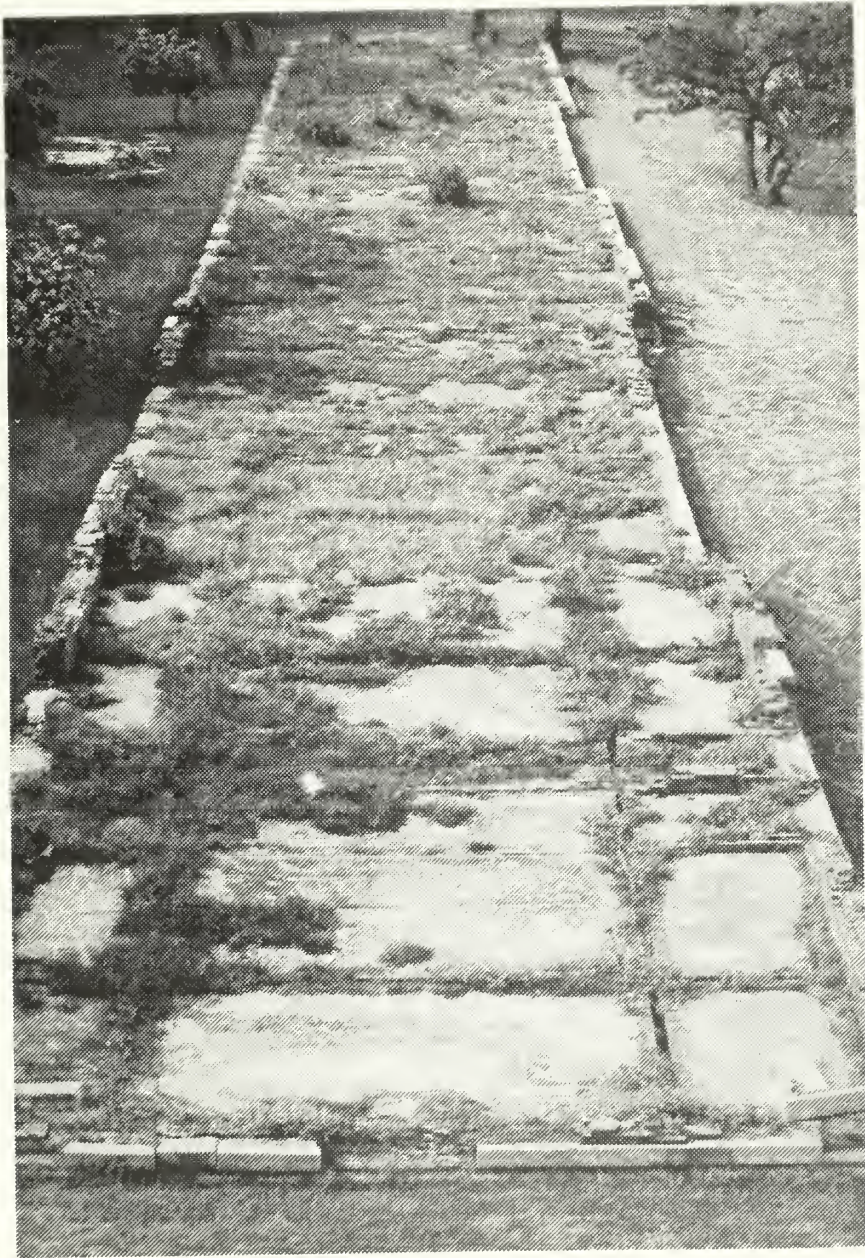
**Figure 13 PRESENT CONDITION**

ENLISTED MEN'S BARRACKS RUINS

The recommended treatment of the enlisted men's barracks is to preserve its present condition for use as an interpretive exhibit. Work involved may include patching of concrete where cracked or spalling, as well as routine vegetative management.

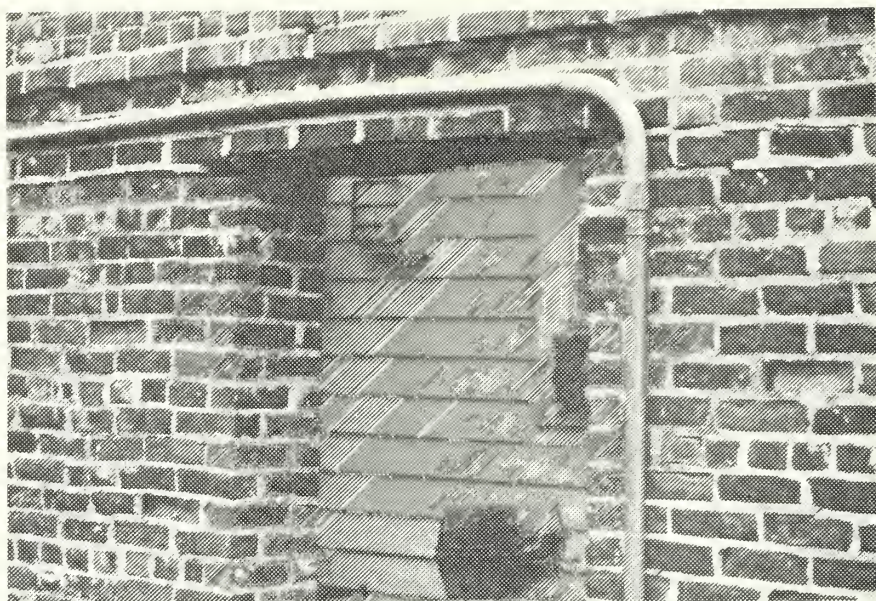
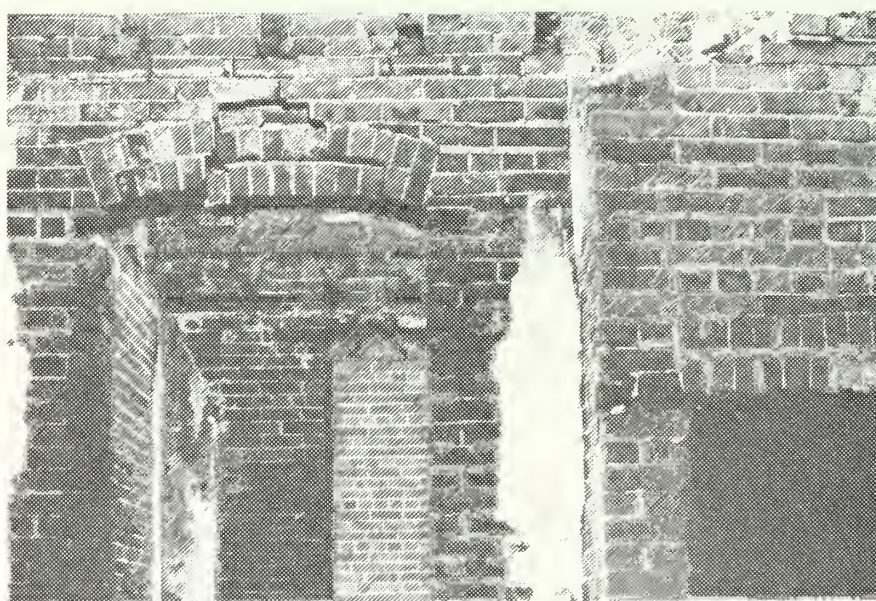
**Figure 14 PRESENT CONDITION**

DAMAGE TO DOORWAY LINTELS

The maintenance of the engineer officers' quarters is recommended to ensure its continued adaptive use as residence quarters for Park Service personnel. As a whole, cyclical maintenance is essential in the context of periodic monitoring and subsequent repointing of the exterior masonry walls to resist moisture transmission due to wind-driven rain. Also, masonry repairs to doorways where exfoliating iron lintels occur is suggested.

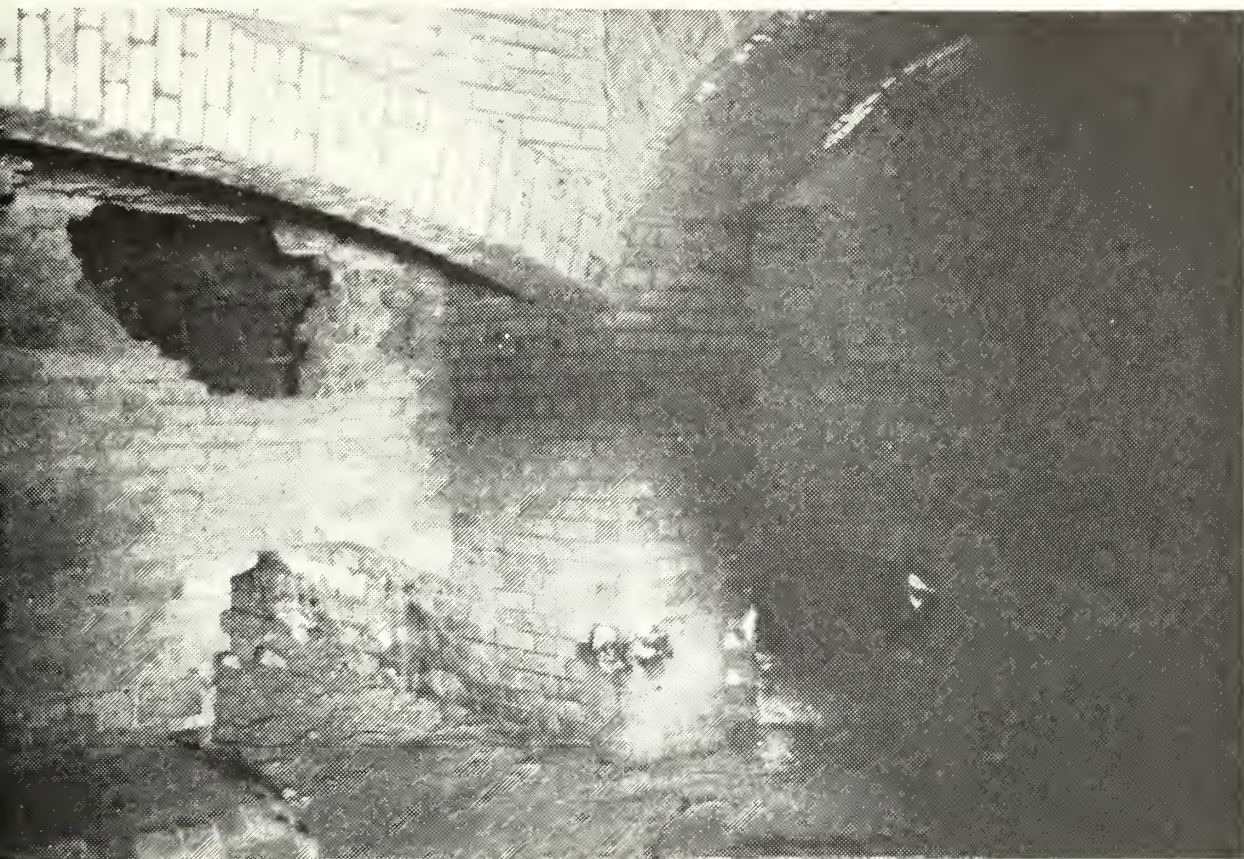
**Figure 16      PRESENT CONDITION**

DAMAGE TO BAKERY WALL

Stabilization involving grouting of structural cracks, treatment of oven ironwork, brick replacement and overall consolidation is recommended for the bakery in addition to auxiliary illumination.

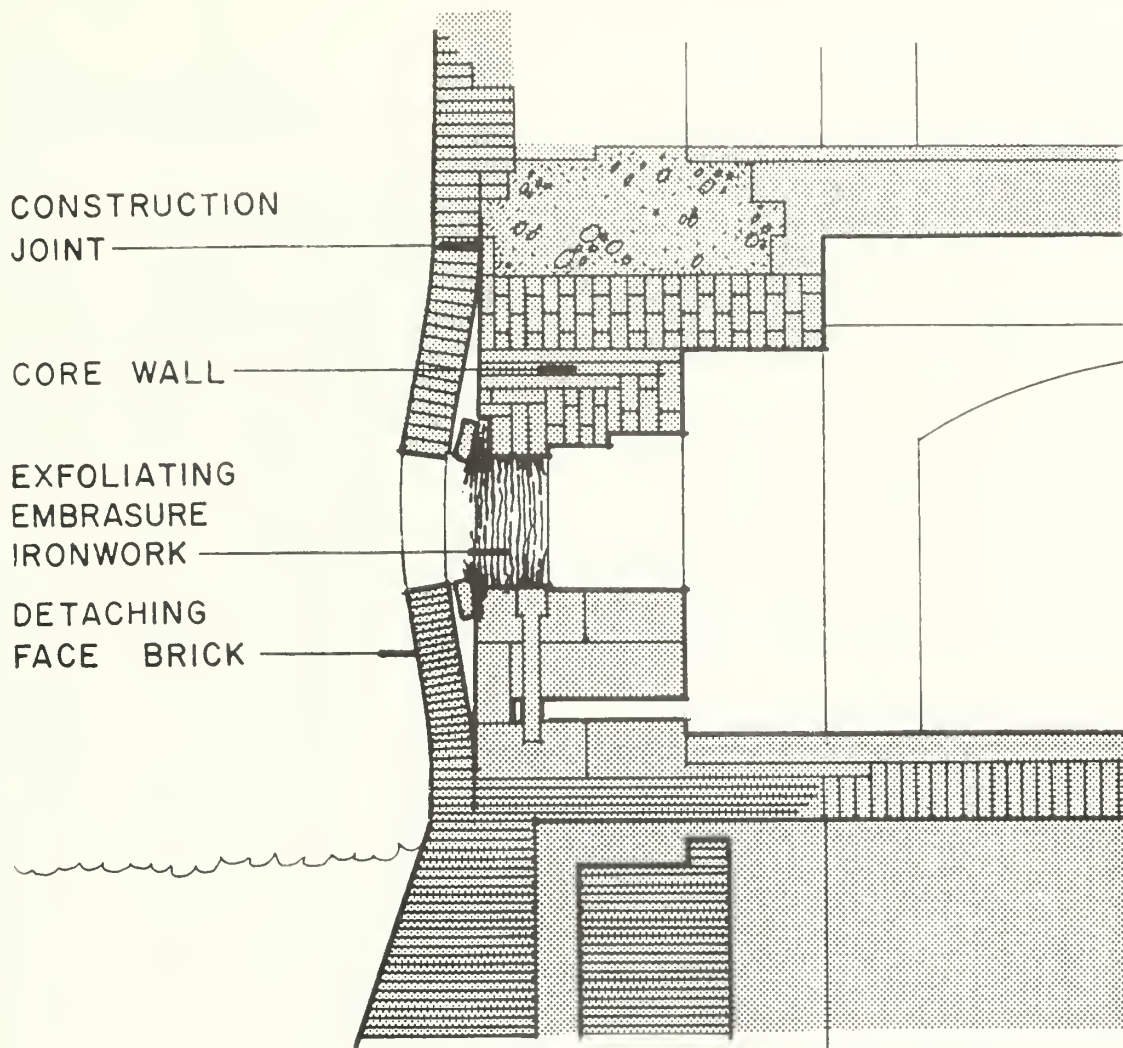
**Figure 18 PRESENT CONDITION**

Front 1 - Seven of 18 lower tier embrasures show bulging masonry resulting from exfoliating ironwork.

**TYPICAL EMBRASURE DETERIORATION**

The recommended treatment for the curtains involves the removal of exfoliating embrasure irons and rebricking of openings to historic dimensions. In addition, a major repointing effort, including the replacement of missing brick in selected areas, is strongly recommended. Cracks in the scarp should be monitored on an ongoing basis, with repairs recommended for those cracks threatening the structural integrity of the fort.

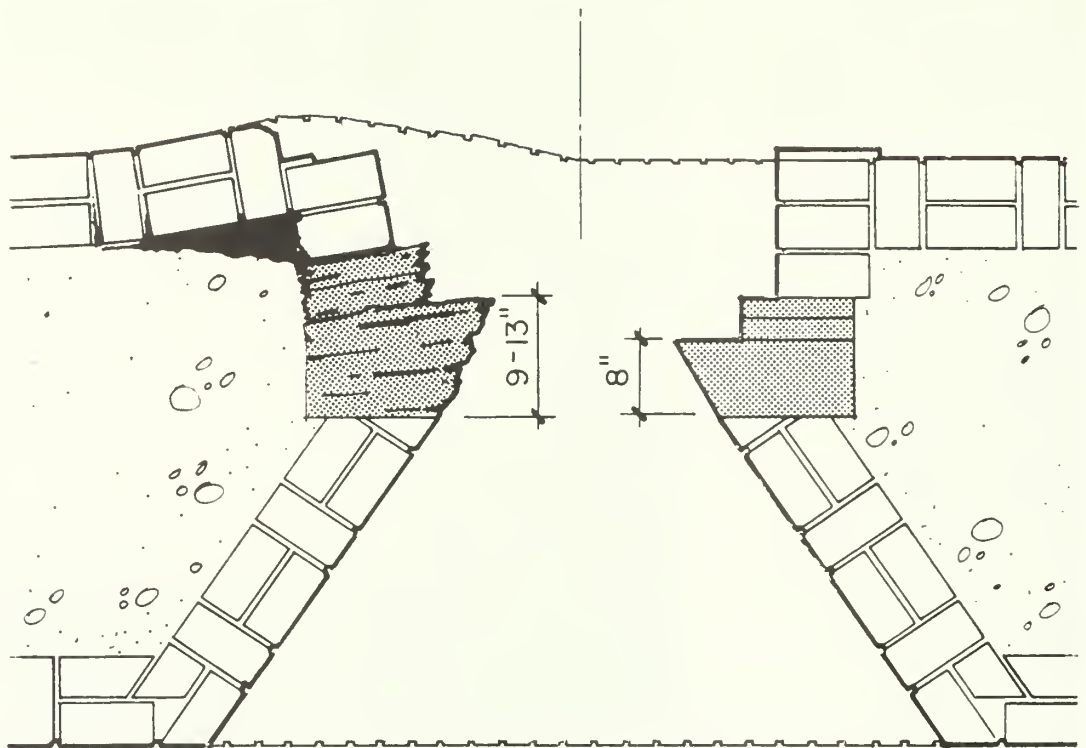
Figure 19 PRESENT CONDITION

TYPICAL EMBRASURE DETERIORATION

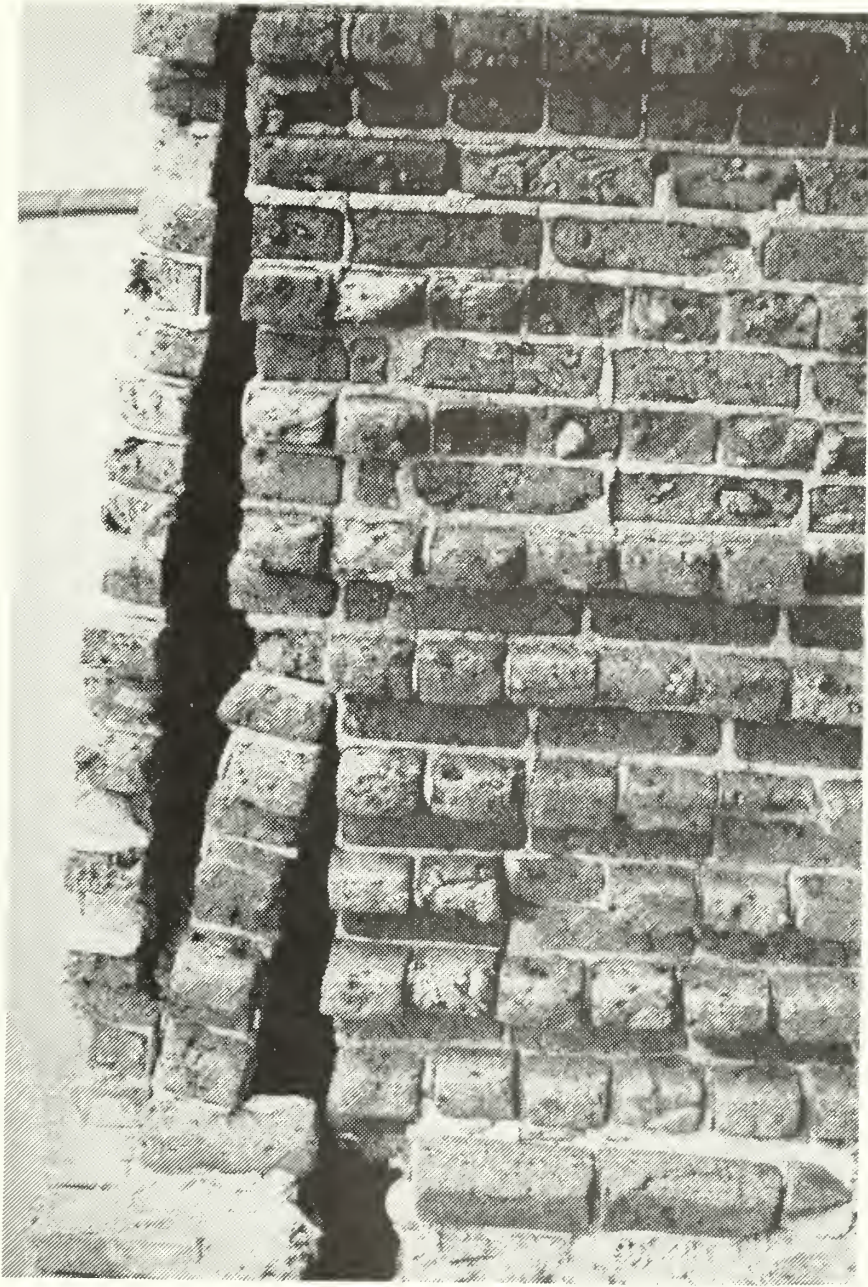
**Figure 20 PRESENT CONDITION**

BULGING EMBRASURE MASONRY

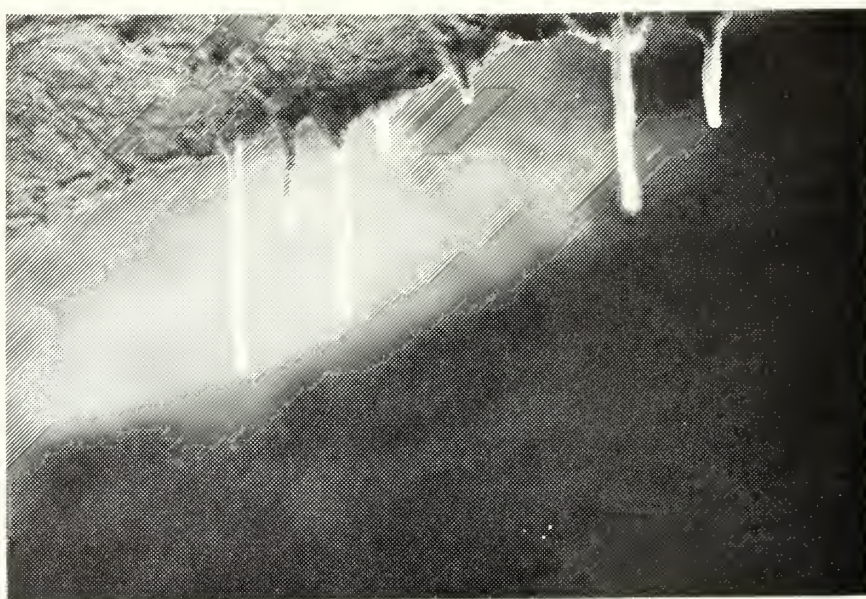
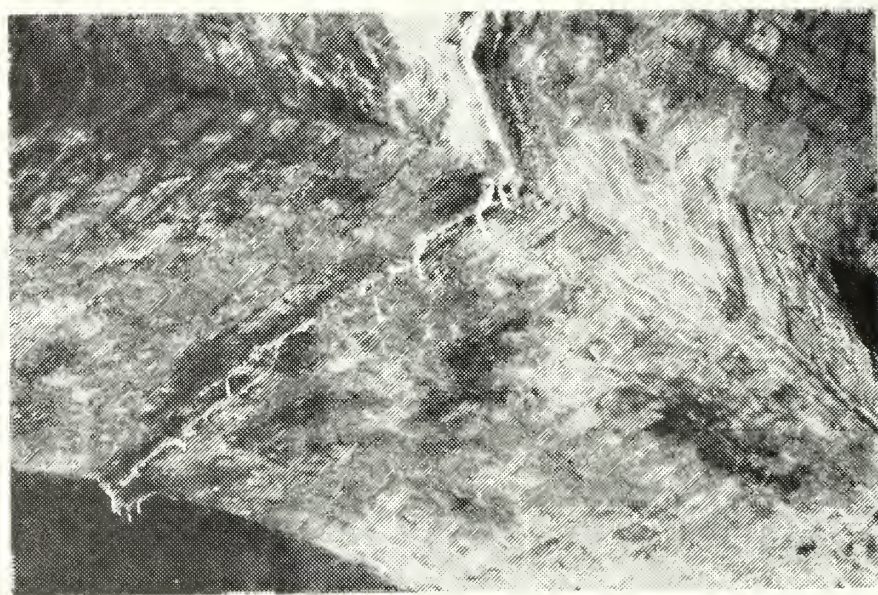
**Figure 23      PRESENT CONDITION**

**CASEMATE MOISTURE**

The recommended treatment for the casemates is to monitor structural cracks in selected areas and repair those cracks of sufficient severity as to pose a threat to visitor safety or the stability of the fort superstructure. The recommended treatment for adaptively used casemates is the installation of some form of waterproofing membrane without permanently damaging historic fabric, and thereby upgrading these areas to suitable standards for human occupancy.

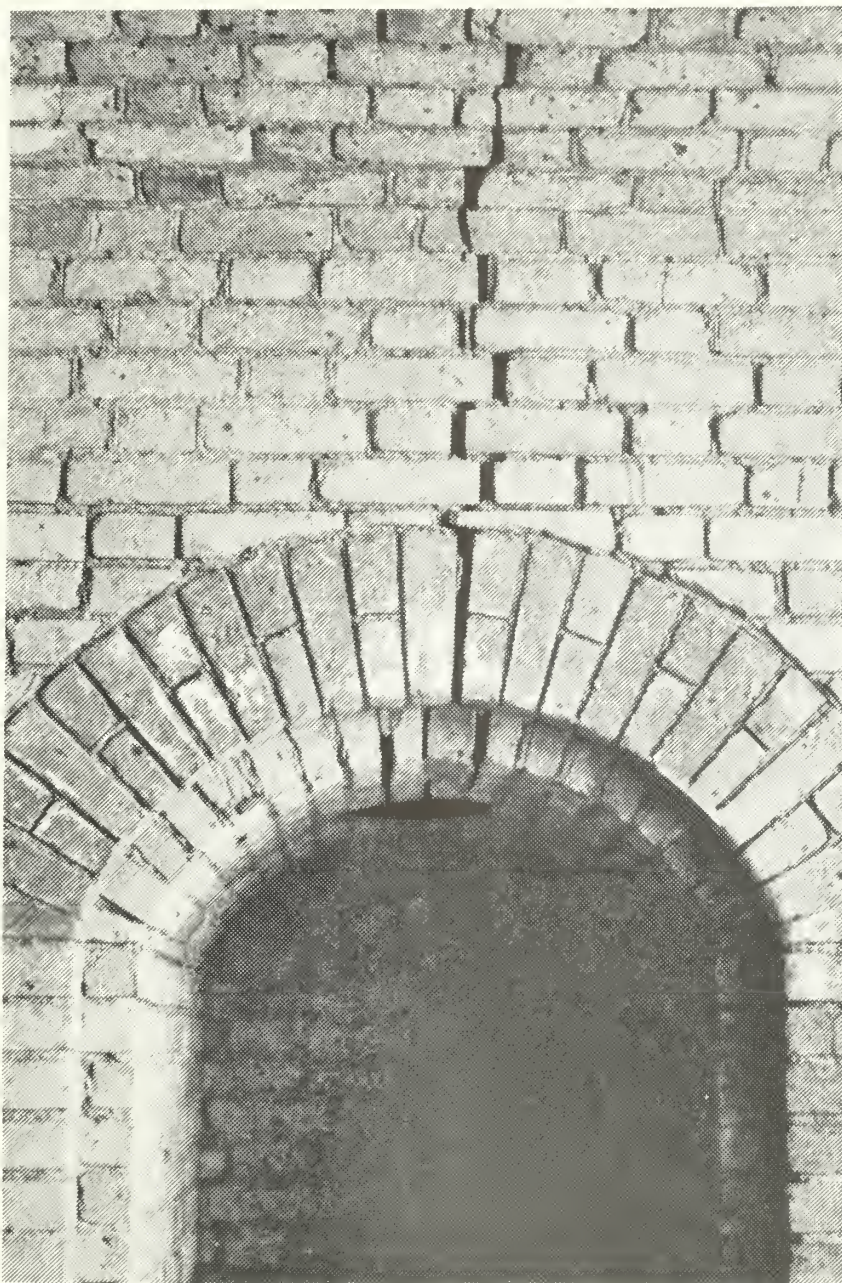
**Figure 24 PRESENT CONDITION**

PIER CRACKING AT CISTERN ACCESS

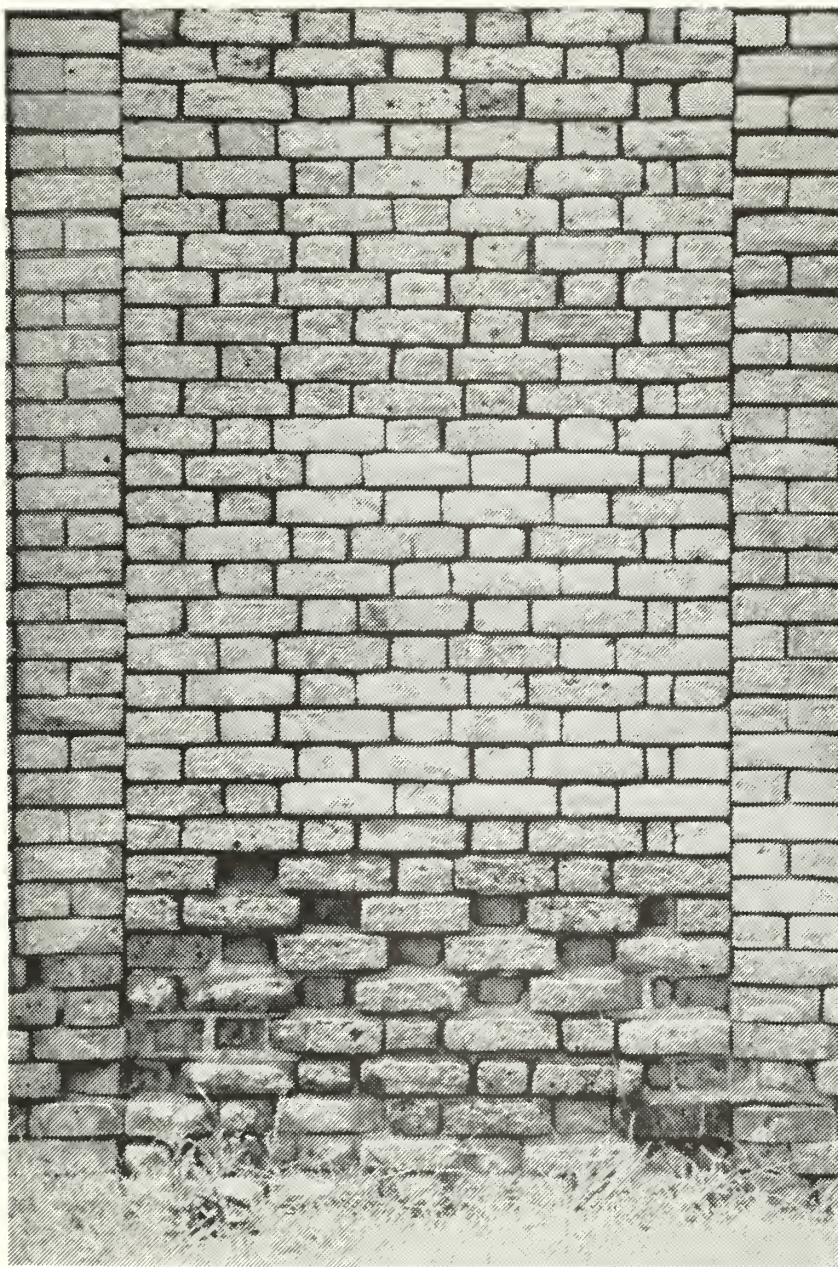
**Figure 25 PRESENT CONDITION**

PIER MASONRY DETERIORATION

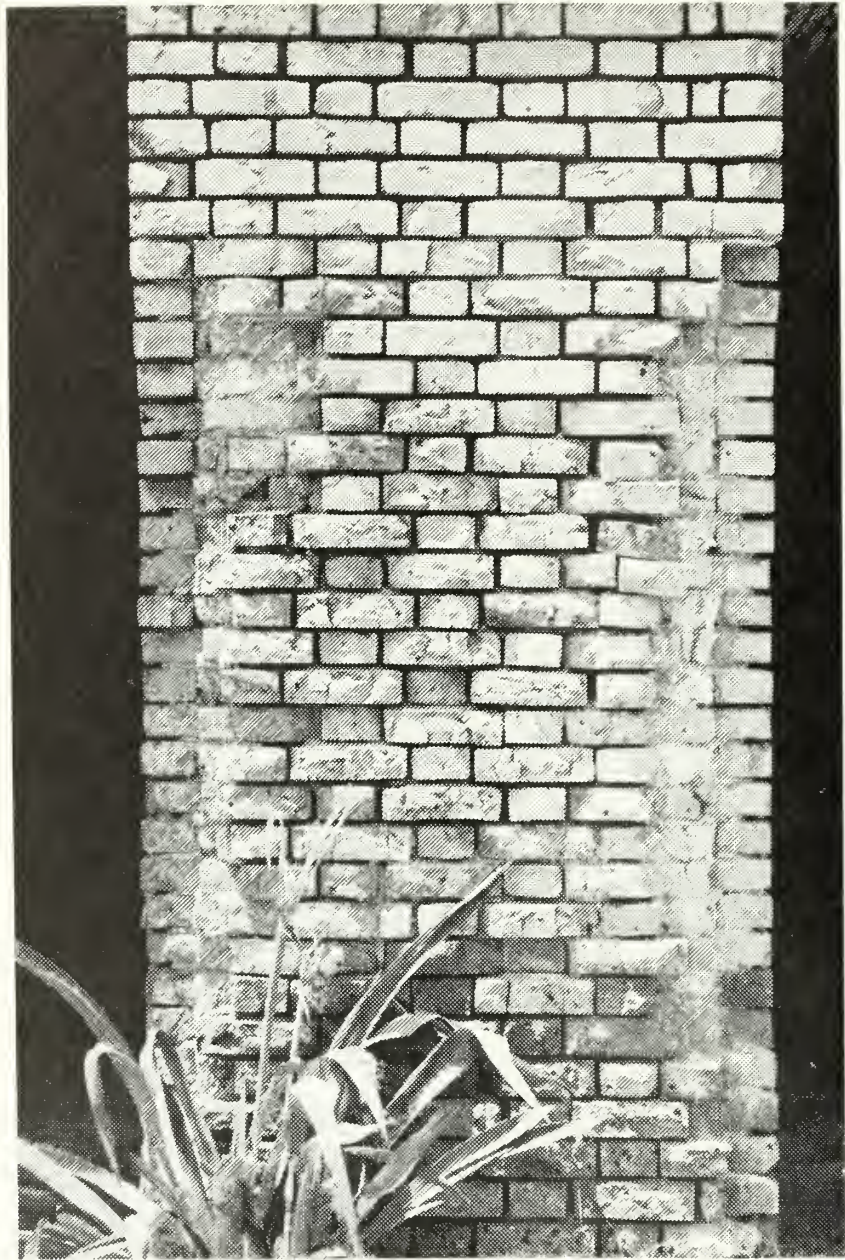
**Figure 26 PRESENT CONDITION**

PIER MASONRY DETERIORATION

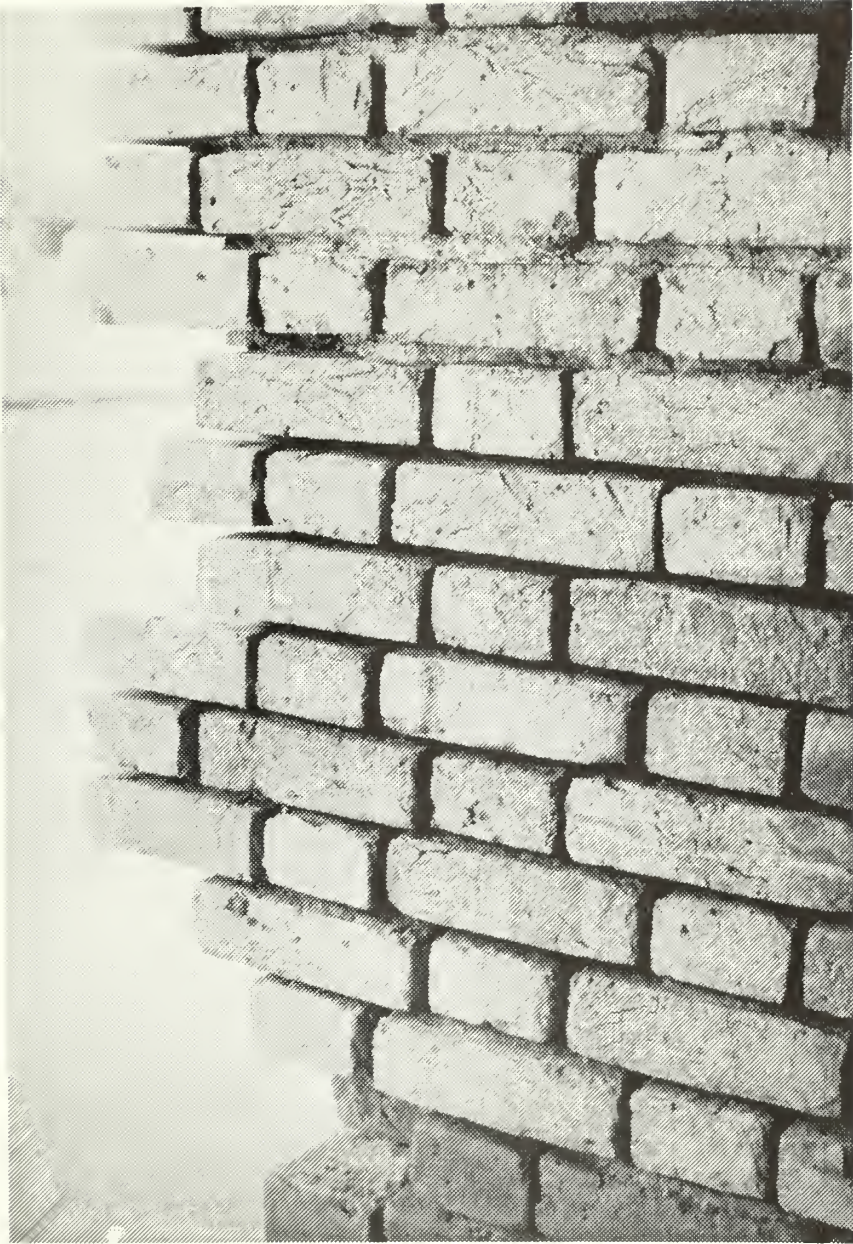
**Figure 27    PRESENT CONDITION**

PIER MASONRY DETERIORATION

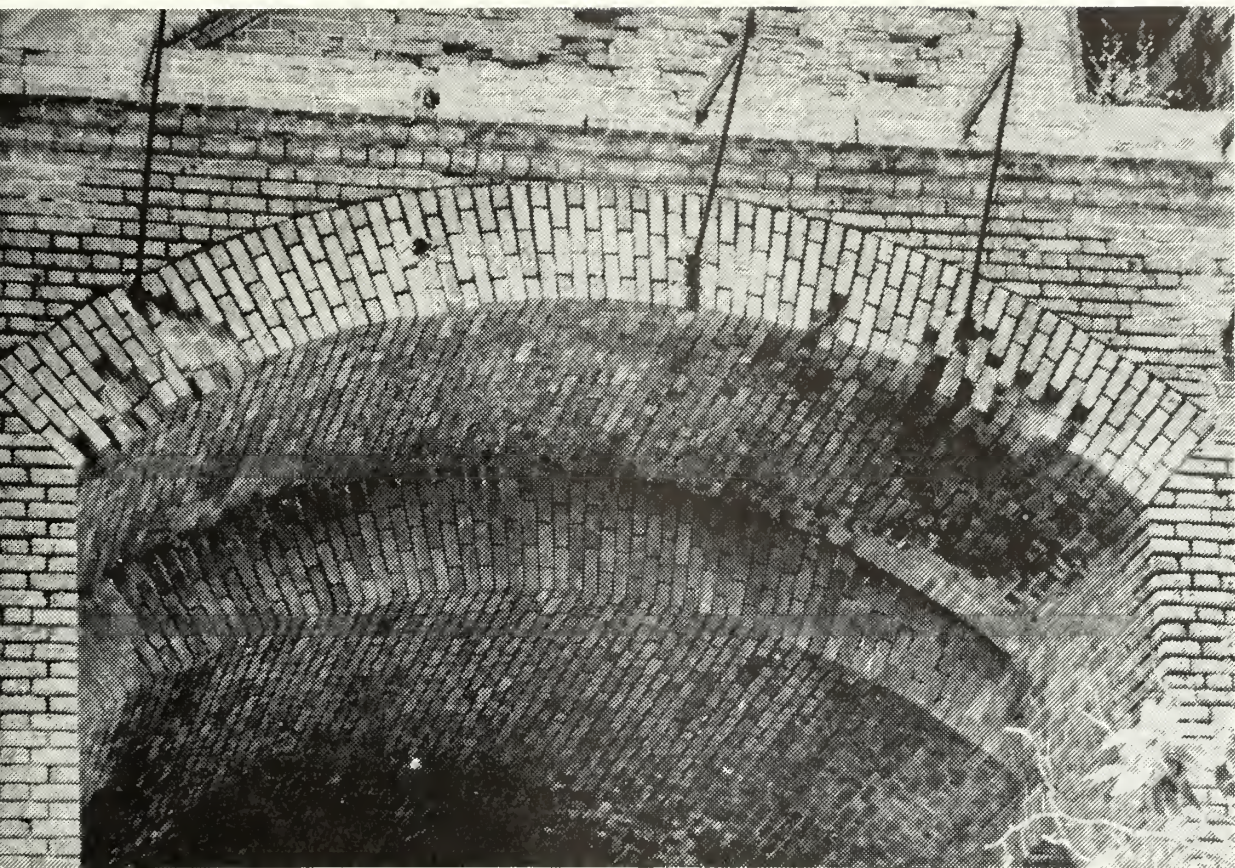
**Figure 29      PRESENT CONDITION**

CASEMATE ARCH DAMAGE

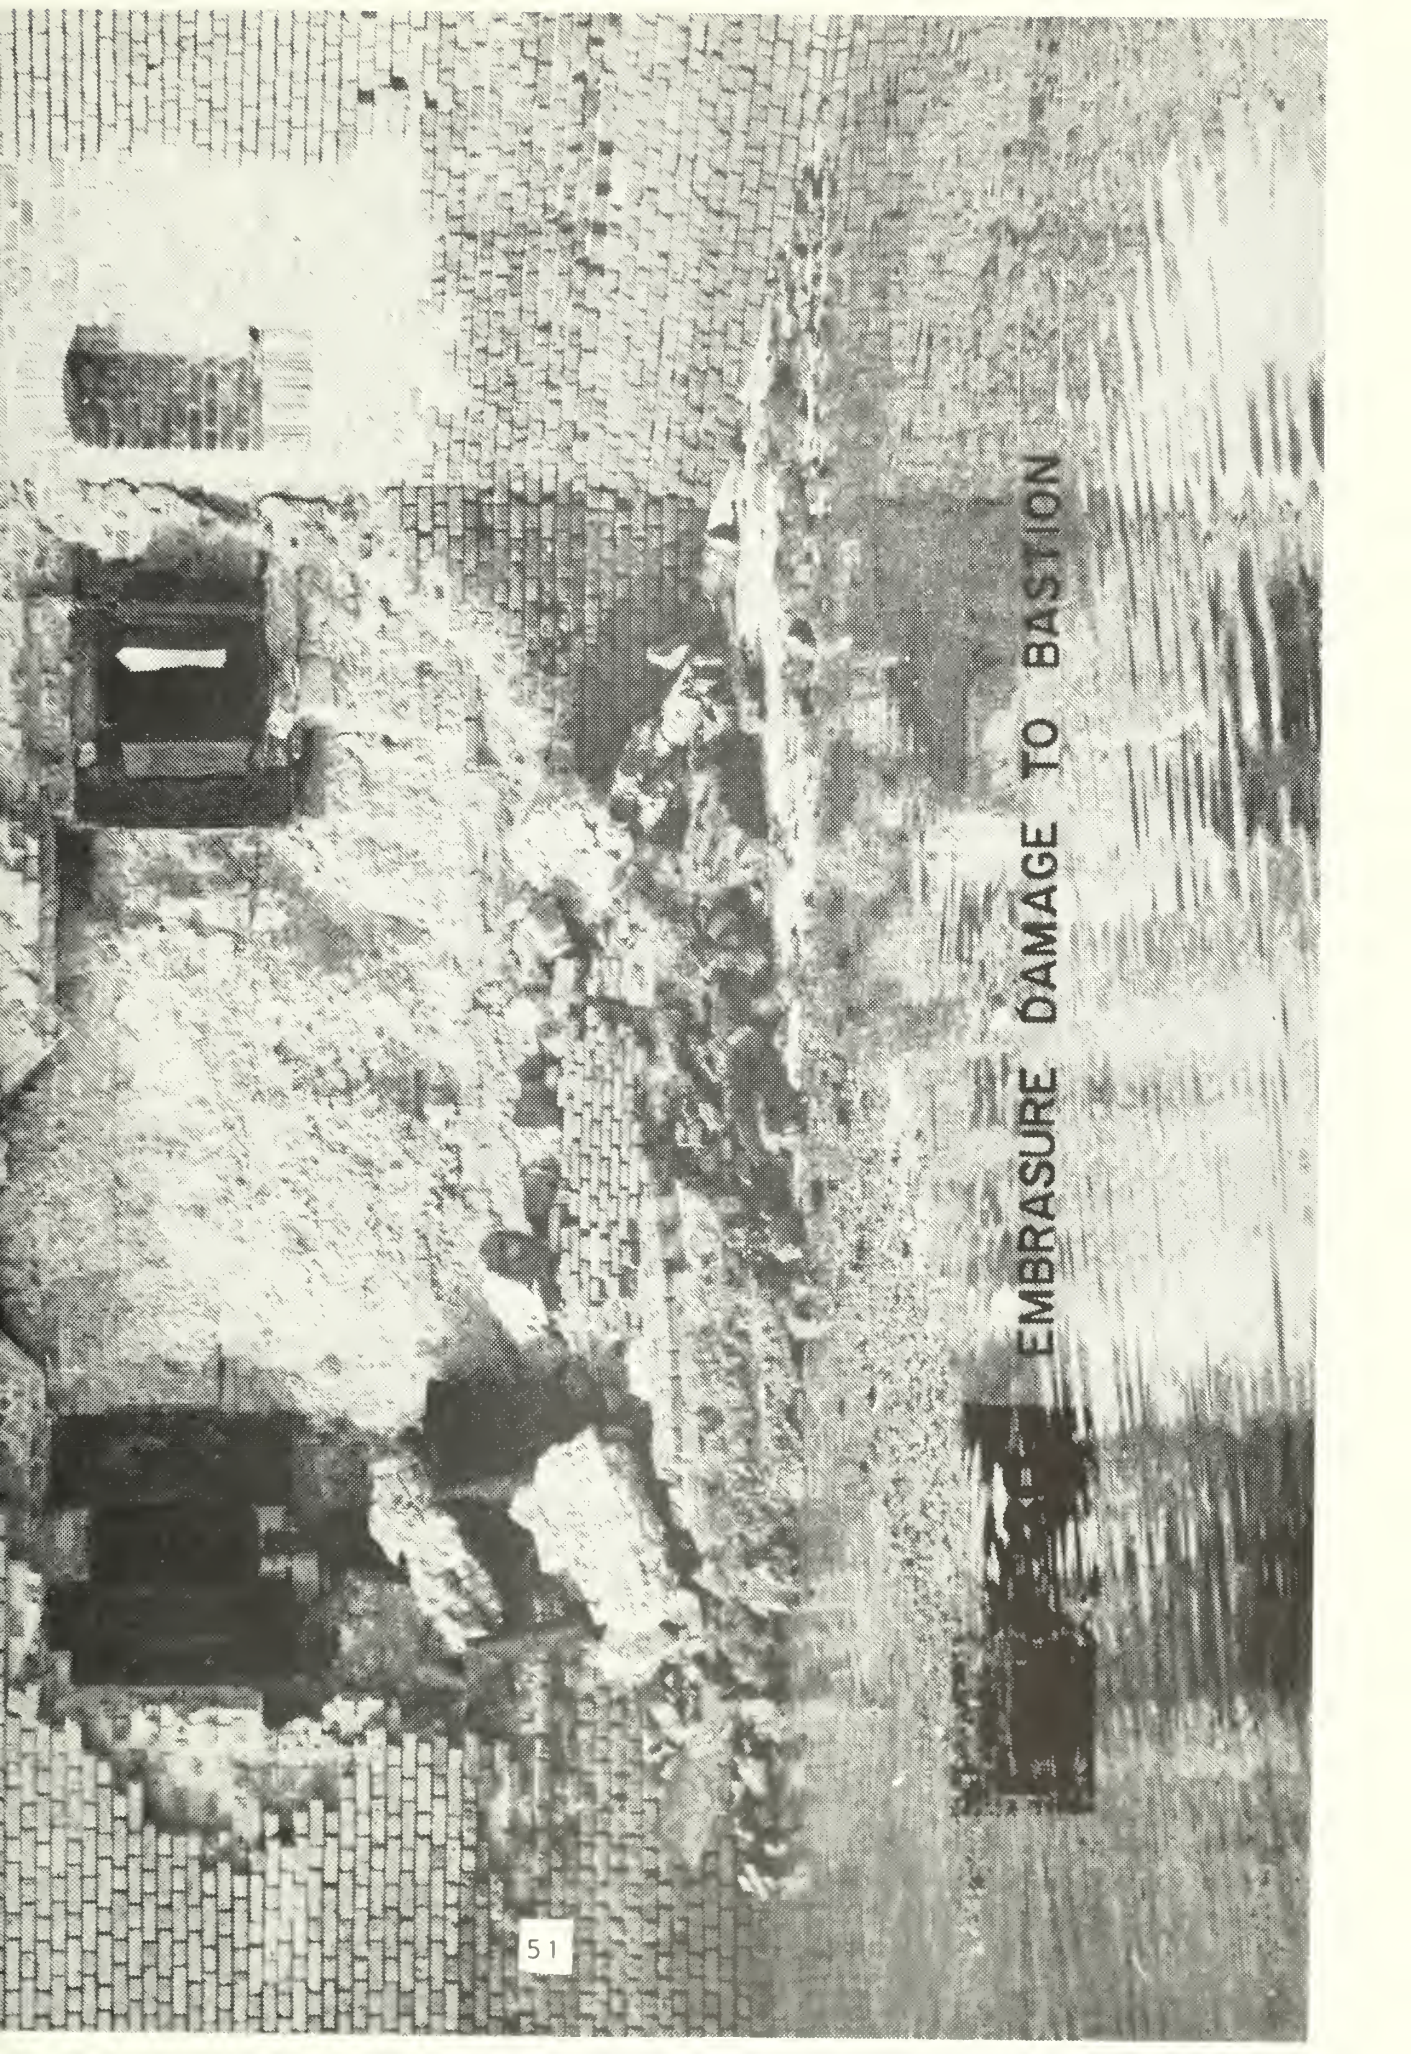
EMBRASURE DAMAGE TO BASTION

The recommended treatment for the bastions involves the removal of exfoliating embrasure irons and rebricking of embrasures to historic dimensions with brick replacement and repointing where needed. The replacement of missing brick and selective repointing is recommended for the stabilization of the stairtowers.

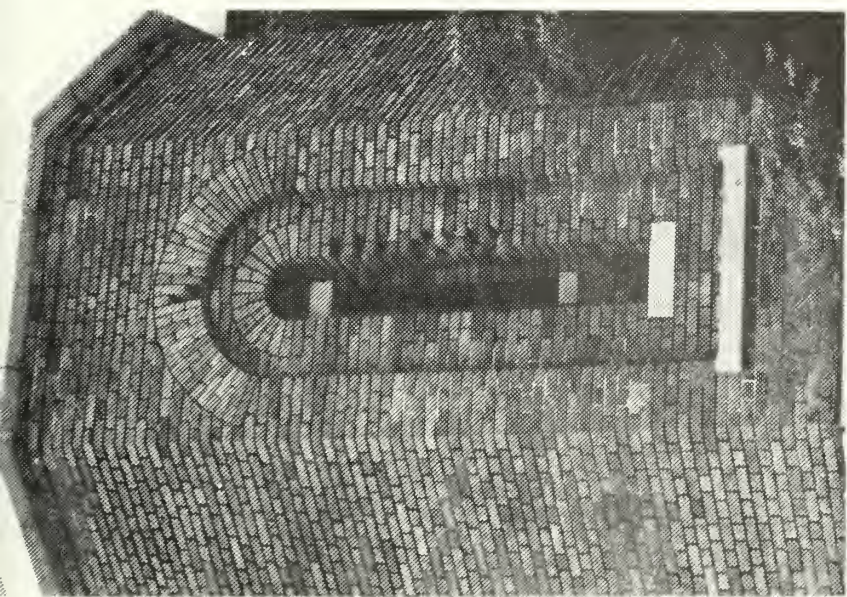
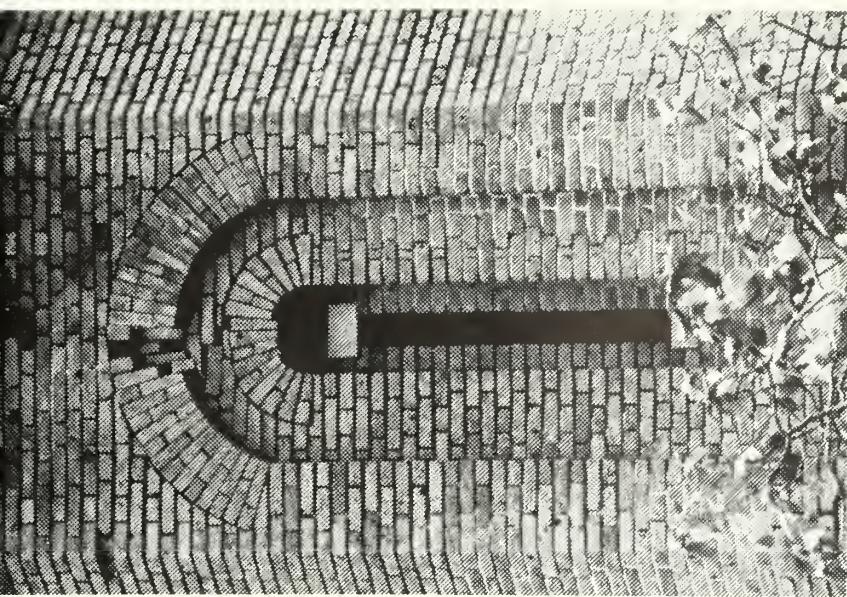
Figure 32

Stairtower 6 - The mortar of the window arches and surrounding masonry has eroded to such a depth that collapse of this area is imminent. At least two dozen brick are visibly displaced in this area and six are

STAIRTOWER DETERIORATION

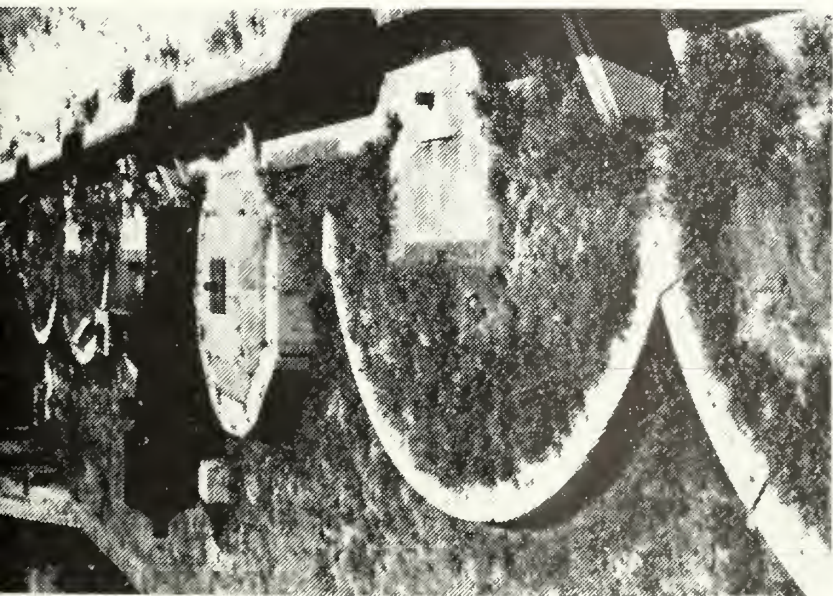
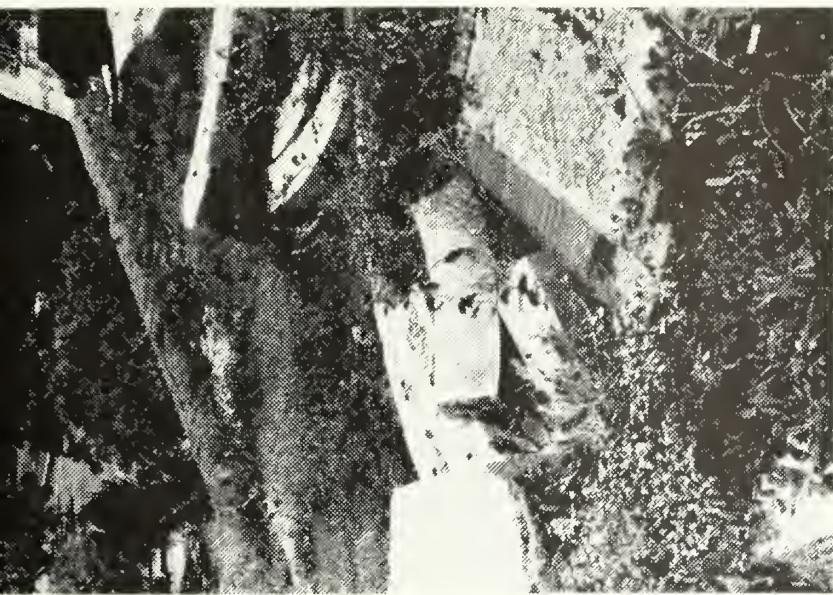
**Figure 33      PRESENT      CONDITION**

Operation of diesel generators on the lower tier of Front 2 has resulted in smoke stains around the gunports through which this equipment exhausts. By-products of diesel combustion are particulates and sulphur dioxide (SO<sub>2</sub>) which occur in comparatively higher concentrations than in gasoline combustion, carbon monoxide (CO) and hydrocarbons, which are relatively lower. Dry masonry, especially having carbon deposits, will absorb sulphur dioxide, which when moistened becomes a dilute sulphuric acid solution. Further, NaCl (from sea) + H<sub>2</sub>SO<sub>4</sub> (pollutant  $\rightarrow$  2HCl (corrosive) + Na<sub>2</sub>SO<sub>4</sub> (very expansive sulphate when crystallizing). Chemical damage will result to lime mortars where sufficient concentrations of these acids exist. Although the degree of deterioration may not be predictable, these conditions do enhance the likelihood of accelerating material decay. Sulphate crystallization could promote spalling of brick as well.

Recommended treatment of the terreplein would include the replacement of the intended sand fill in those areas where missing; the removal of fill, the application of a low-impact, breathing water repellent to the fort roof above Fronts 2 and 3 along with subsequent replacement of displaced fill; controlling the levels of vegetative growth throughout
